HISTORIC STRUCTURE REPORT:  
THE CUSTOM HOUSE AND TOWER

VOLUME II:  
EXISTING CONDITIONS AND RECOMMENDATIONS

SARA B. CHASE  
and  
ANNE A. GRADY

SOCIETY FOR THE PRESERVATION OF  
NEW ENGLAND ANTIQUITIES  
CONSERVATION CENTER

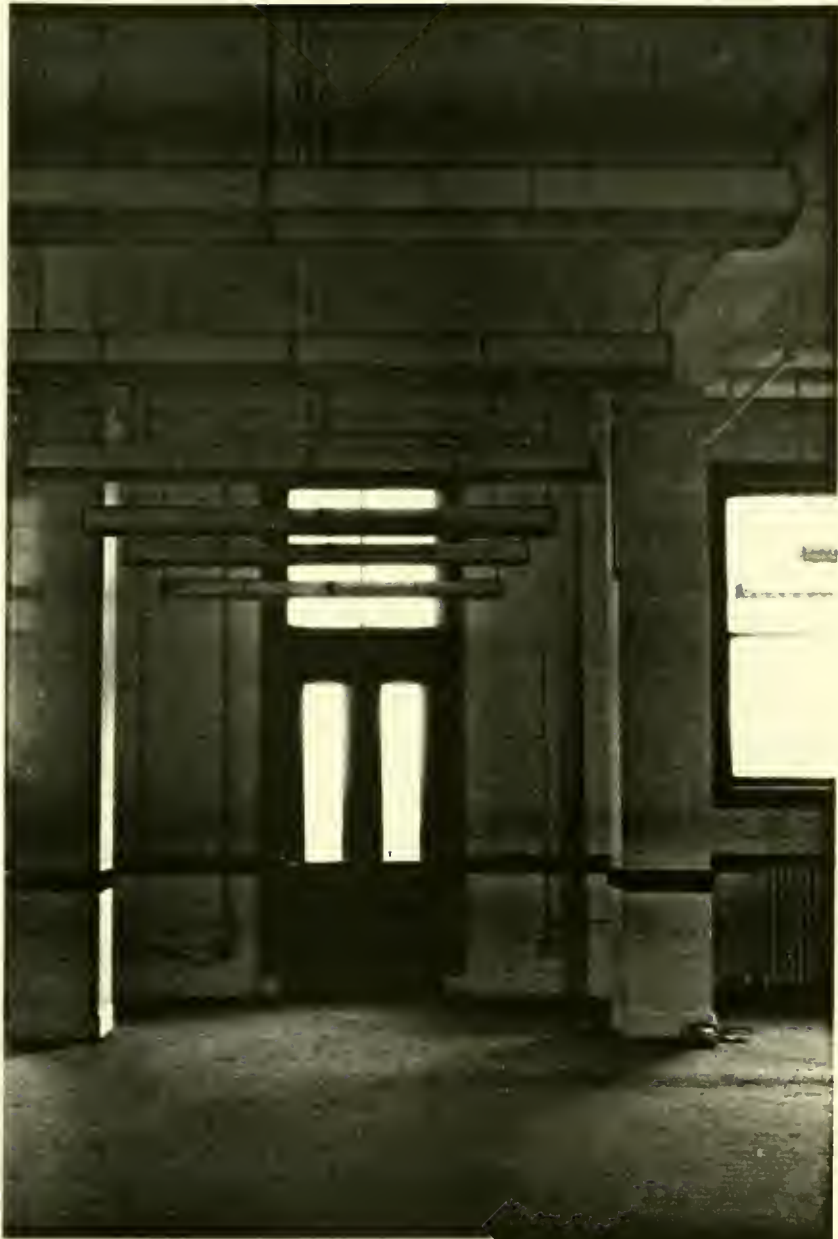
Figure 47

Element	Material/Description	Condition	Photo#
Floor	carpeted over granolithic	carpet good	47
Base-board	terra cotta, painted	some chips and nicks	
Walls	plaster, painted	water damage along east wall	48, 49, 50
Cornice	no - picture rail	good	
Ceiling	plaster, painted	signs of water damage North and East 10-15%	51
Windows	Kalamine	typical corrosion, but good	
Window Frames	painted graining on metal	good, sills are marble and soiled	52
Doors	painted metal and glass	fair	
Door Frames	painted metal	fair	
Hardware	brass plated	fair to poor	
Elect. Fixt.	egg crate	poor	
Special Features

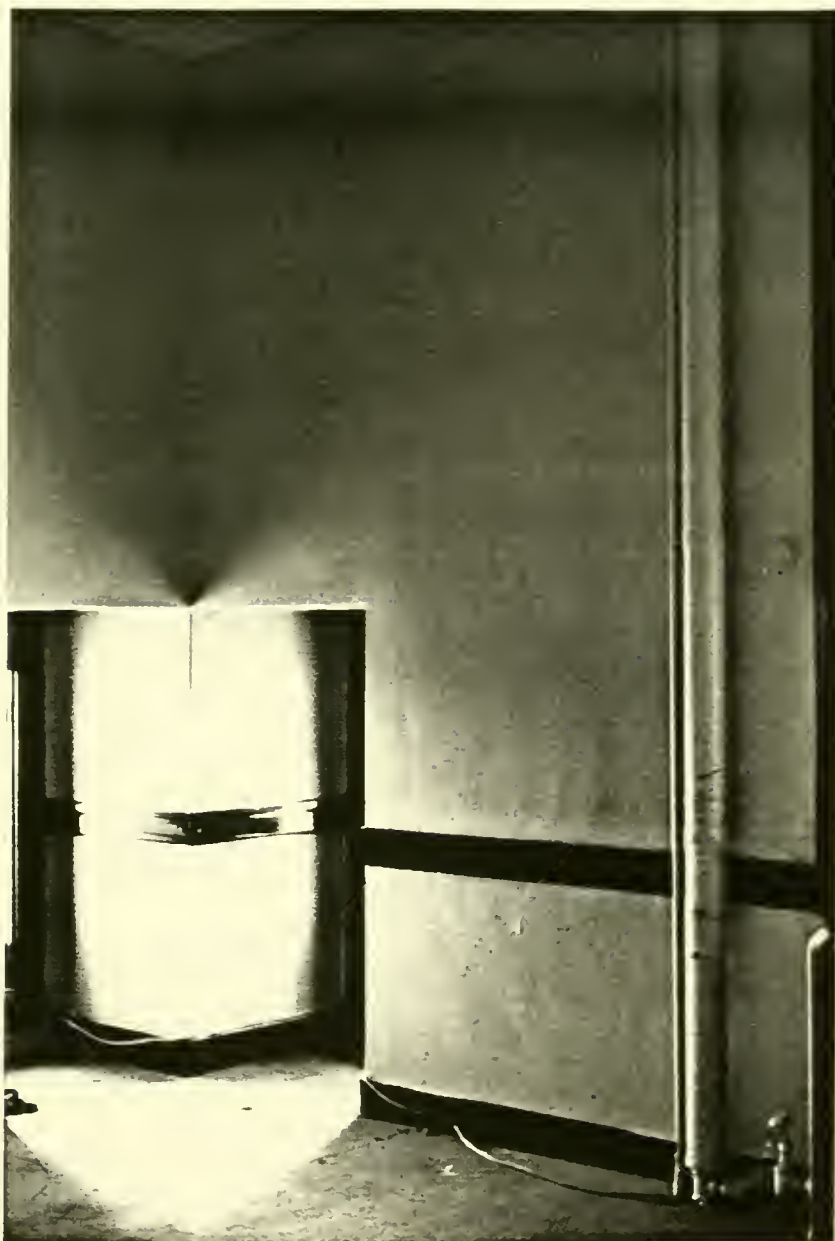
Figure 53

Element	Material/Description	Condition	Photo#
Floor	carpet or linoleum over ?	poor	
Base-board	painted terra cotta	fair	
Walls	plaster and wall board	fair to poor	
Cornice	(picture rail exists)		
Ceiling	dropped acoustical tile	poor - broken	
Windows	small, simpler, very typical	fair to good	53, 54
Window Frames	small, simpler, very typical	fair to good	
Doors	small, simpler, very typical	fair to good	
Door Frames	small, simpler, very typical	fair to good	
Hardware	small, simpler, very typical	fair to good	
Elect. Fixt.	removed		
Special Features

Remarks: East wall not peeling here; iron grilles over east sash set into exterior marble and badly rusted. Small corner windows at floor level add much light.

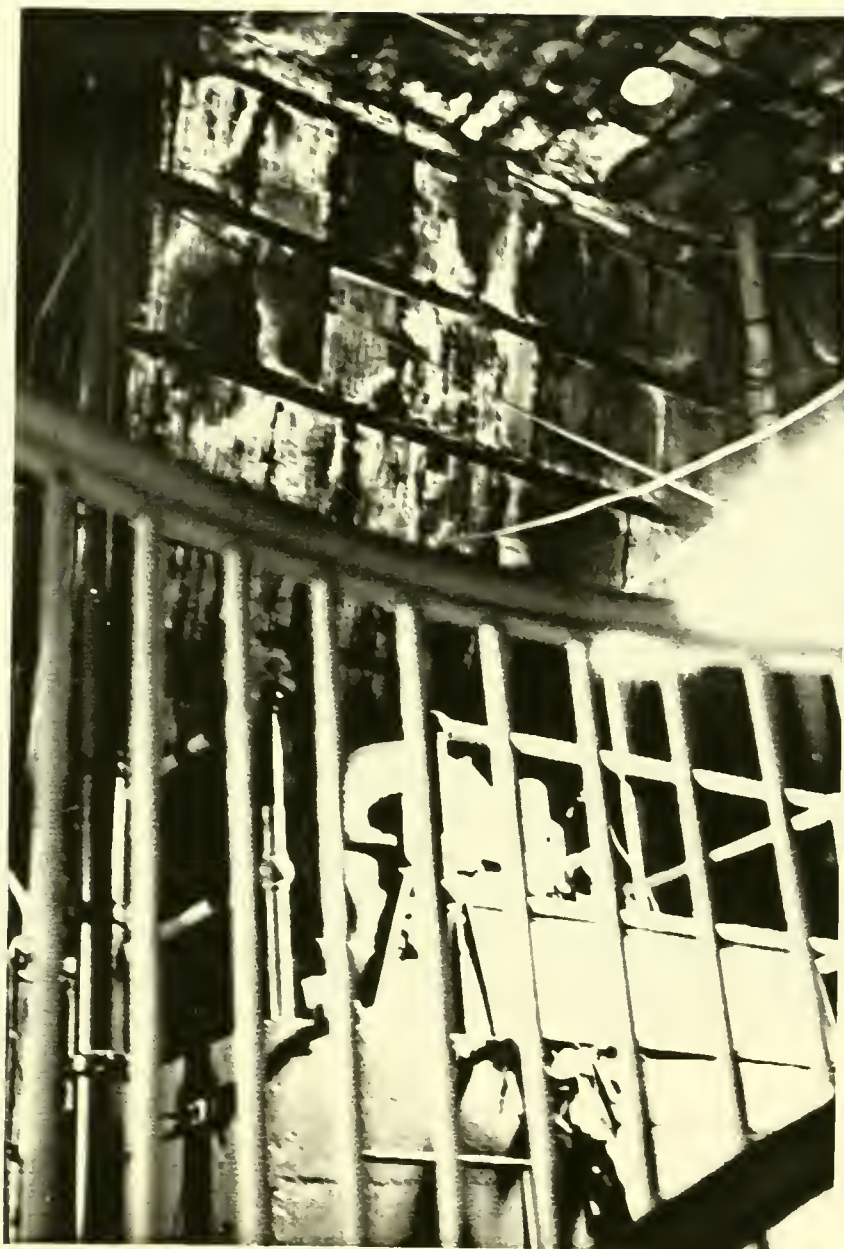
Figure 61

Element	Material/Description	Condition	Photo#
Floor	scored concrete	painted and inpainted	
Base-board	none		
Walls	exposed grooved terra cotta block	all effloresced, plaster remnants	61
Cornice	none		
Ceiling	exposed grooved terra cotta block		
Windows	none		
Window Frames	none		
Doors	none		
Door Frames	none		
Hardware	none		
Elect. Fixt.	fluorescent bars		
Special Features			
Remarks: No windows. Balustrade is basket weave ironwork. Plaster parging all gone.

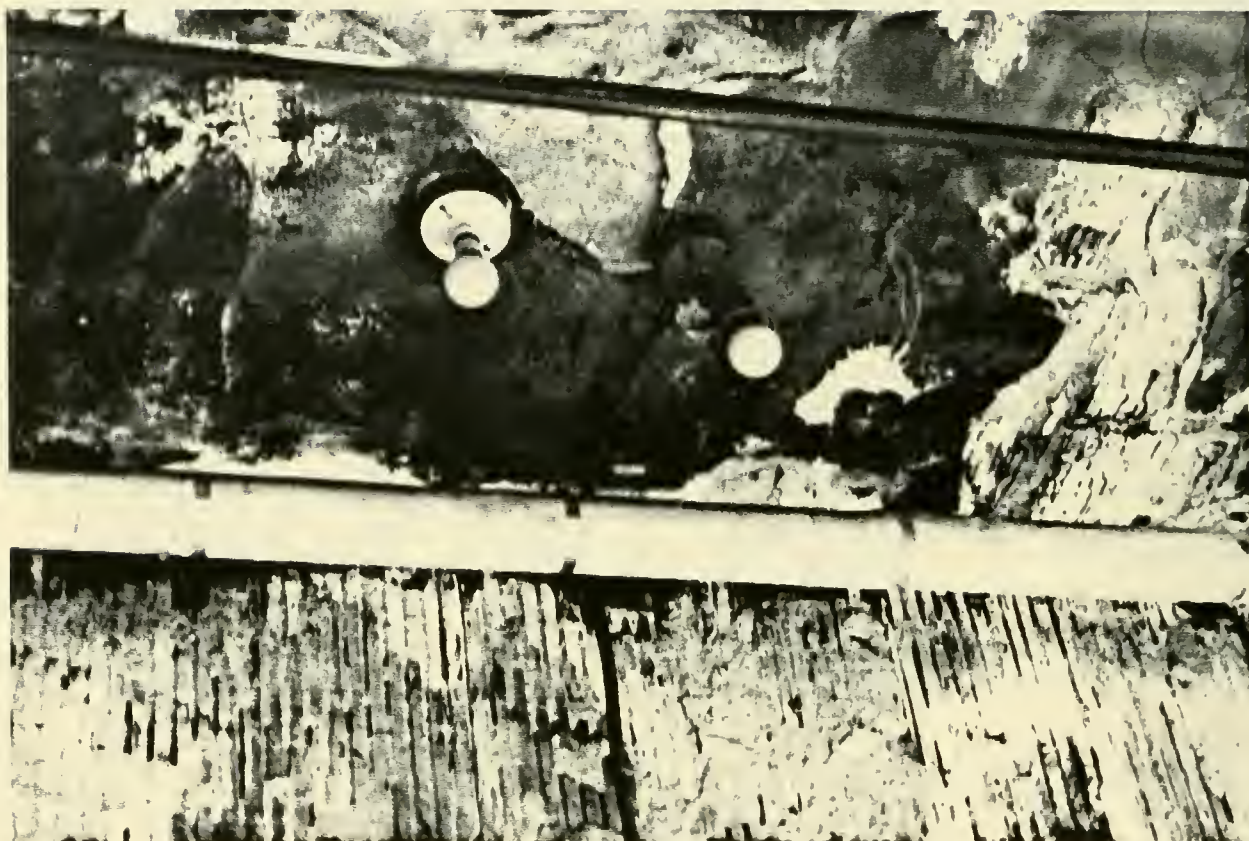
Figure 62

Element	Material/Description	Condition	Photo#
Floor	smooth but textured concrete	poor	
Base-board	flat red terra cotta	poor to fair	
Walls	grooved terra cotta block	poor - all effloresced, minor plaster remains	
Cornice	none		
Ceiling	plastered, painted gray	all cracked and peeling	62
Windows	Kalamine	fair	63
Window Frames	Kalamine	fair	
Doors	none		
Door Frames	none		
Hardware	none		
Elect. Fixt.	none		
Special Features

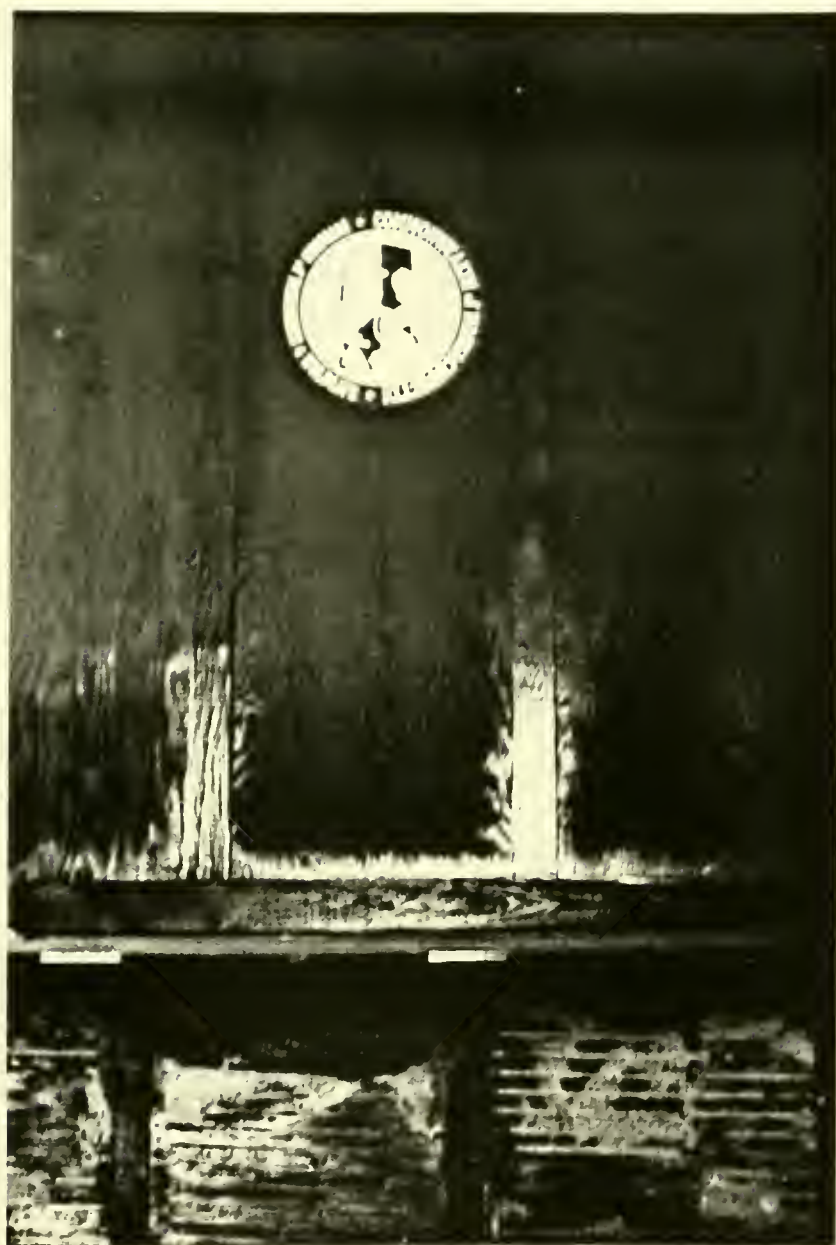
Figure 67

Element	Material/Description	Condition	Photo#
Floor	smooth but texture of concrete	poor to fair	
Base-board	red terra cotta	poor to fair	
Walls	grooved terra cotta block	poor - all effloresced, minor plaster remains	
Cornice	none		
Ceiling	plastered, painted gray	all cracked and peeling	
Windows	Kalamine (marble sills)	fair	
Window Frames	Kalamine	fair	67
Doors	none		
Door Frames	none		
Hardware	none		
Elect. Fixt.	none		
Special Features

Remarks: All is fair to poor, like Floor 28 in most respects but spiral stair just needs and preparation. Sash from East wall is stored here. Falcon nesting box in East window.

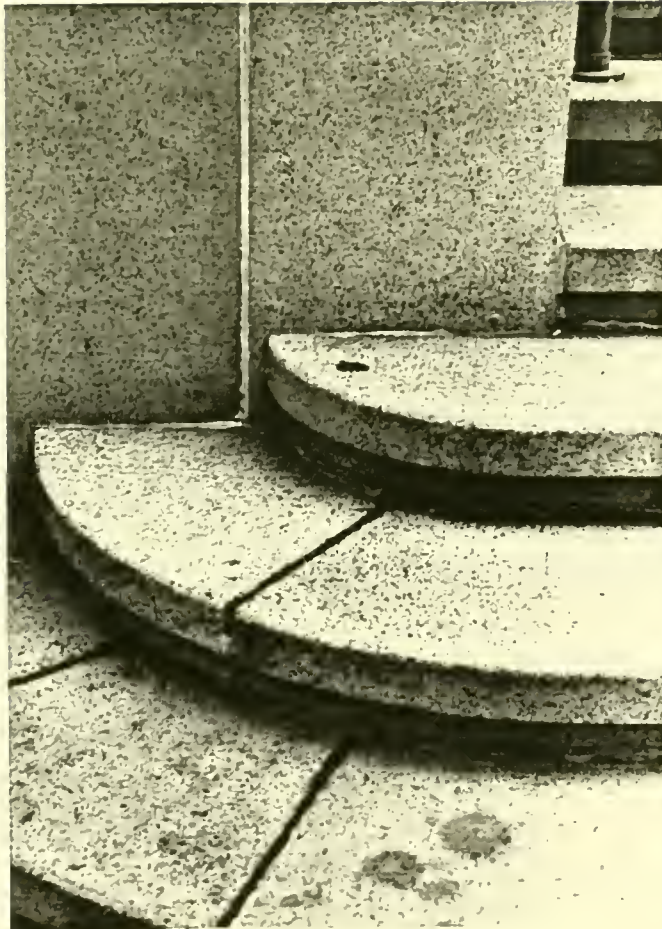
3 - Detail of stairs to west entry showing need for pointing and caulk.

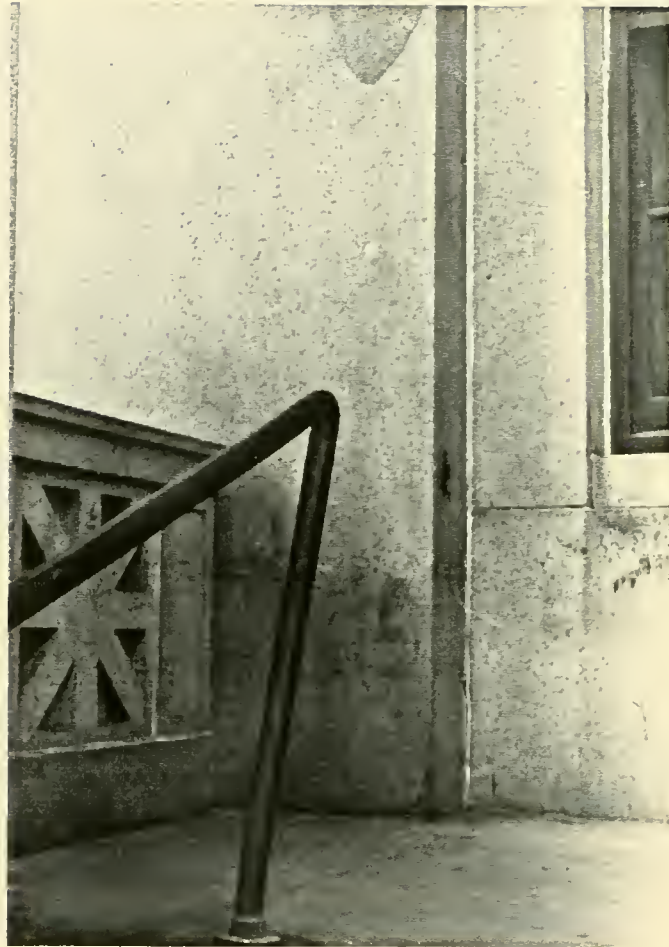
4 - Detail of bent handrail, north side of west entry.

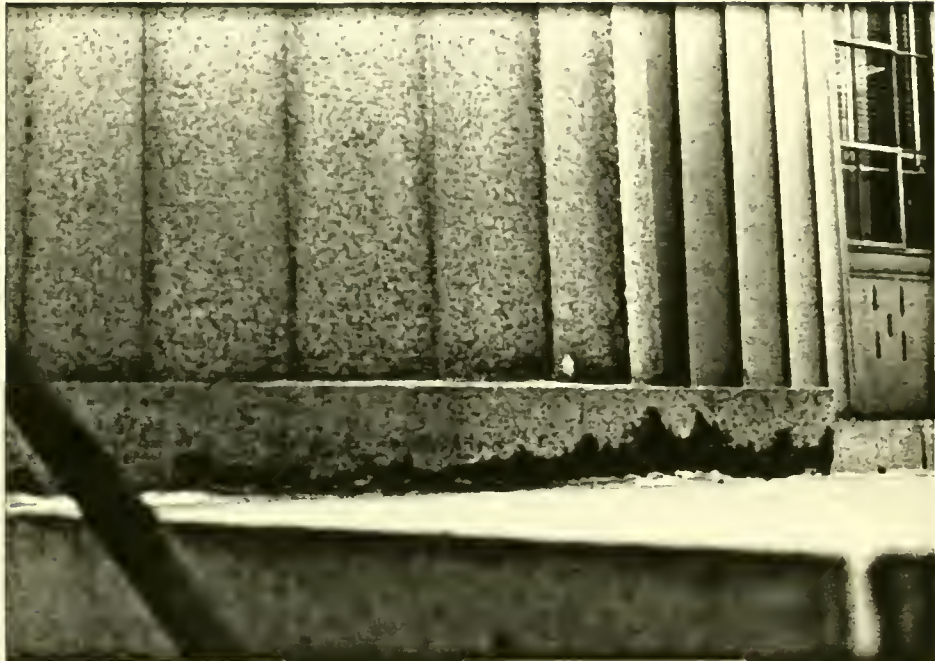
5 - Detail of chipped base of granite column of west facade.

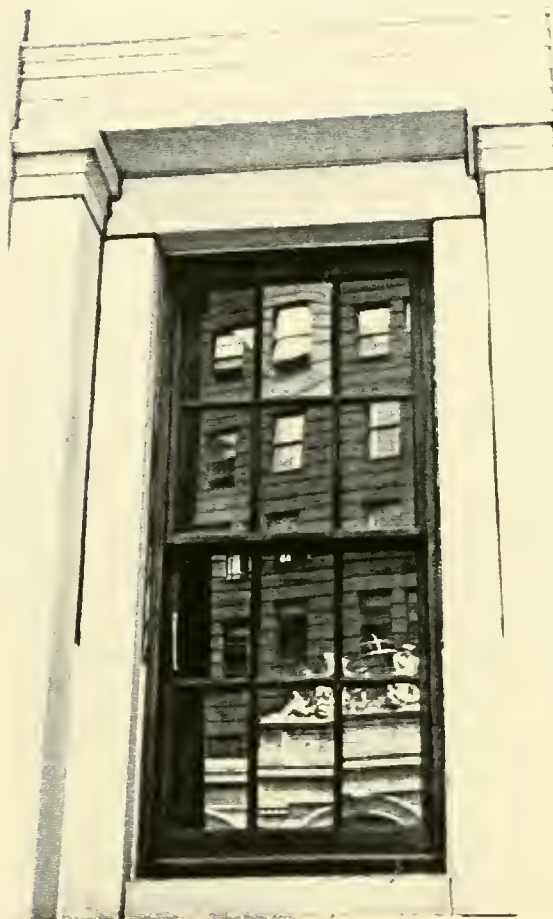
6 - Window over west entry doors, showing black caulk used poorly.

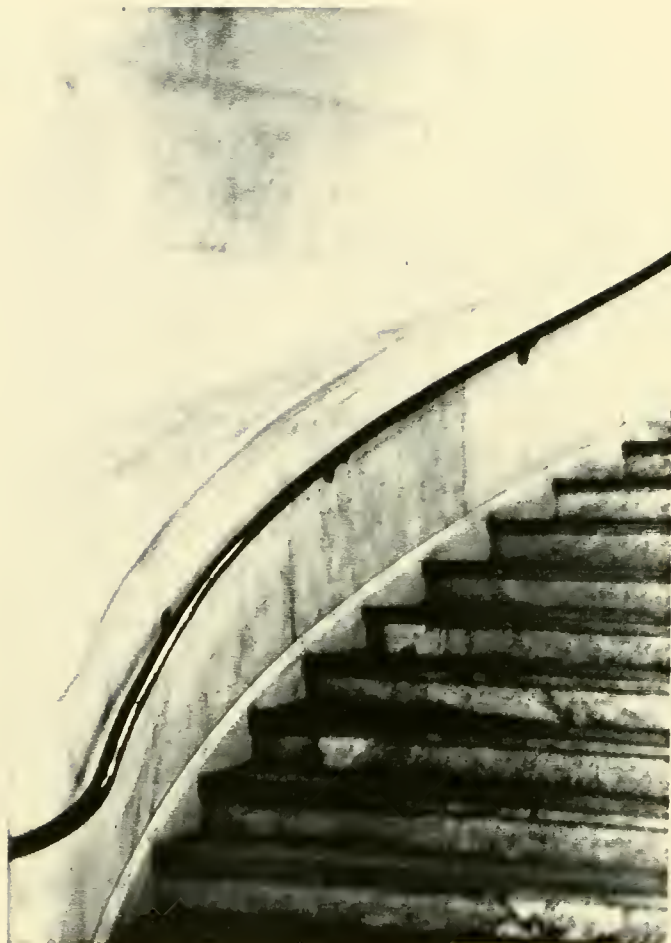
24 - View of the main stairs (Peabody and Stearns) to the second floor showing granolithic treads placed on top of marble, c. 1950, and general uneven appearance of marble.

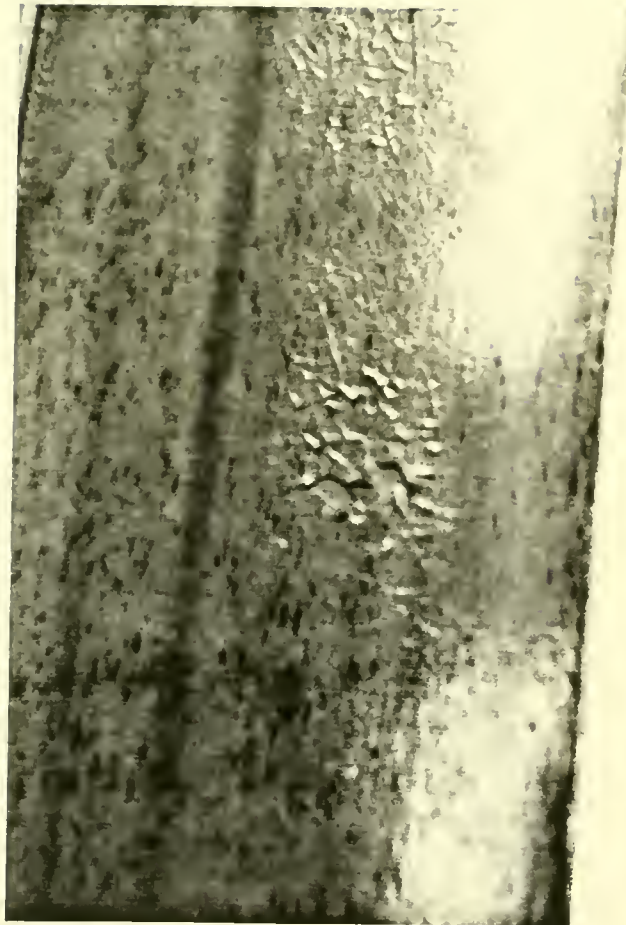
27 - Detail of painted graining on metal door outside Banking Room, showing a paint problem typical on about 2% of the surfaces.

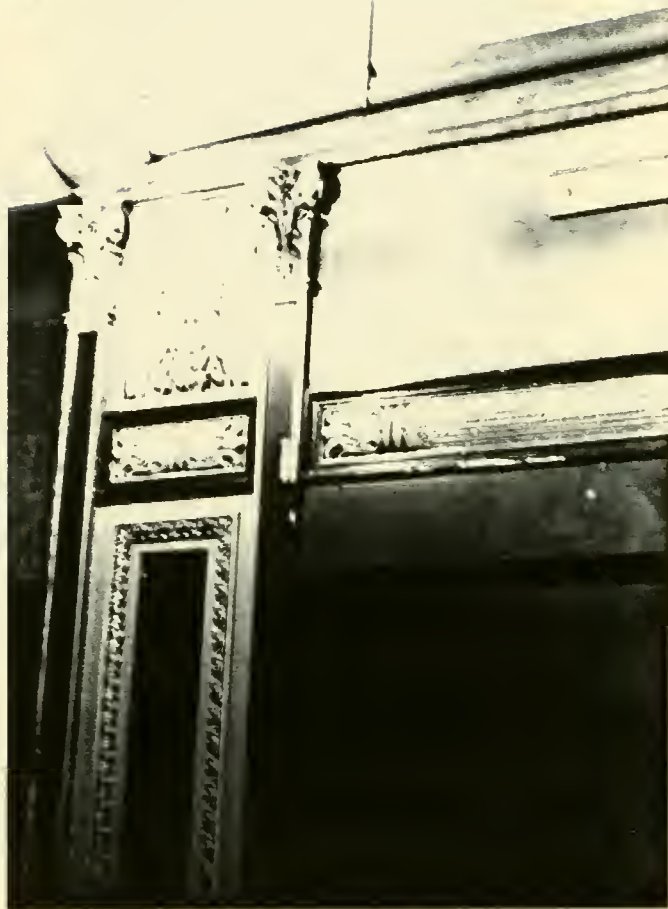
28 - View of elevator detail on second floor, showing trim which post-dates Peabody and Stearns, and was originally painted with a bronze gold paint when new.
